Che Café Facility Renovation Feasibility

January 12, 2015

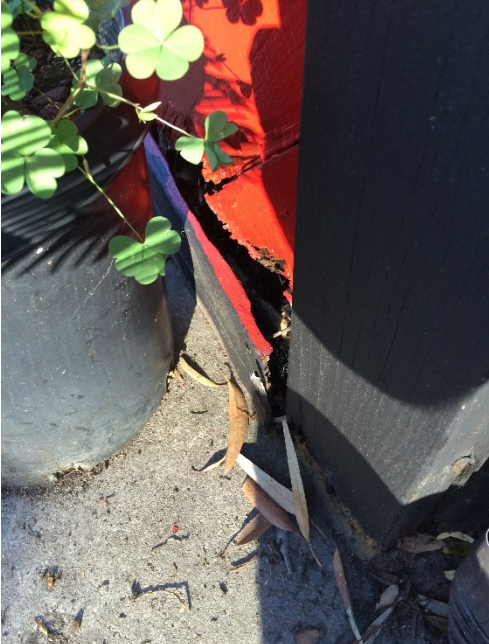
Rotting bottom plate at Main Building
331

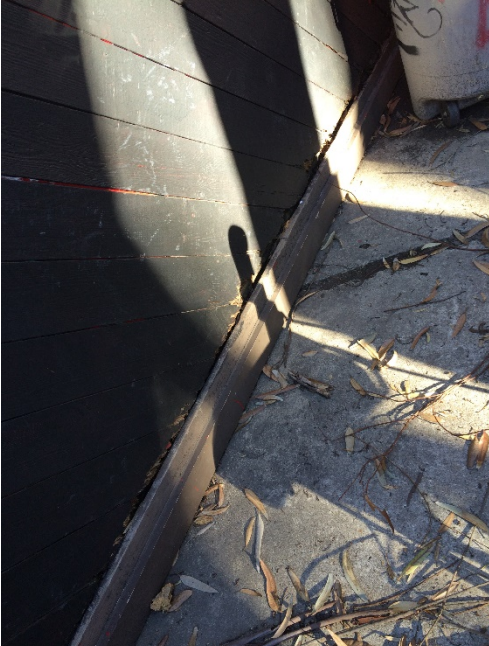
Rot at exterior wall bottom plate of Main Building
333

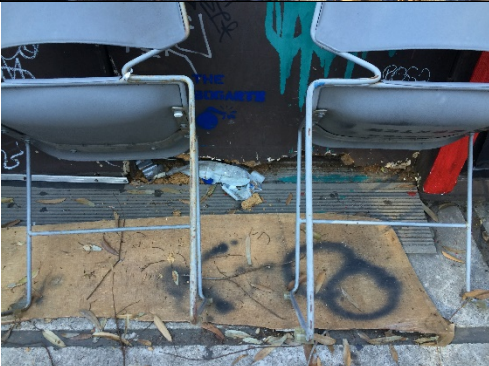
Rot at Exterior door, Vermin entrance

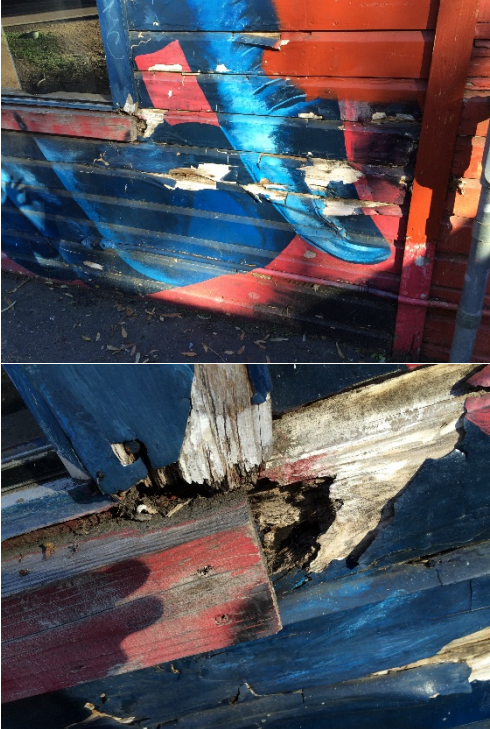
The North building houses the kitchen and the restrooms and has had undocumented additions to both the north and south sides. The walk-in cooler was yet a later addition to the north addition. The roof of the cooler is flat and water ponds at the south side against the kitchen addition. As a result there are extensive leaks in this area and part of the ceiling in the cooler has collapsed. There is evidence of mold in all the walls of the cooler and also in the south wall of the kitchen. The kitchen hood is not equipped with the proper fire prevention devices, and may not be able to be retrofitted. The location/condition of a grease trap is unknown. The restrooms do not meet current accessibility requirements, and cannot be made to do so within the current footprint of the building. The west wall of this building has extensive dry rot due to the site draining into this wall.

Extensive DryRot of exterior wall of Kitchen Addition
336

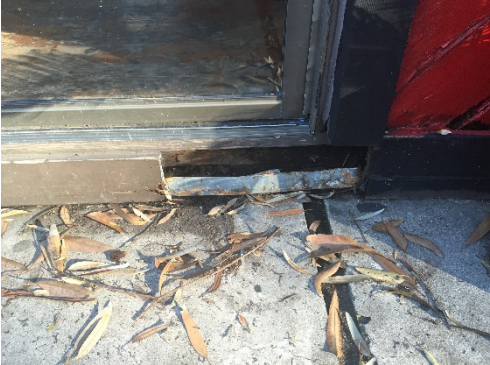
Complete decay of Bottom plate at Main Building
338

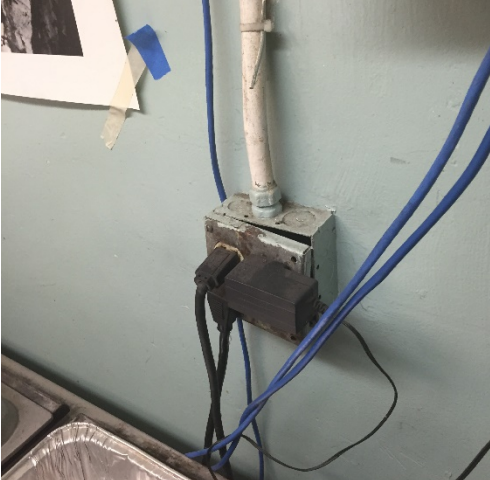
Non-code-compliant Electrical

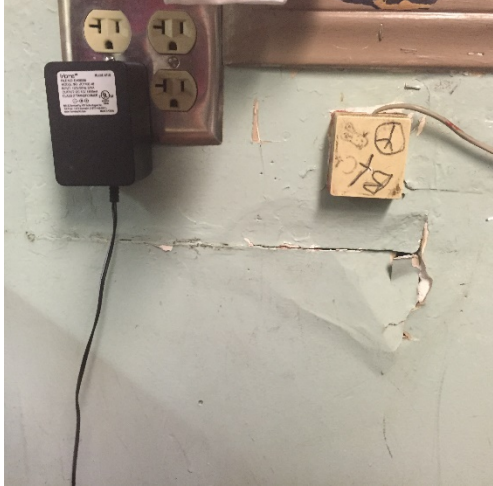
A photograph of a kitchen wall. On the left, there is a power outlet with a black electrical device plugged into it. To the right of the outlet is a wooden tag with a circle and slash symbol and some handwritten text. The wall appears to be made of a light-colored material, possibly drywall or plaster, and shows some signs of wear and discoloration.	Mold at interior kitchen service counter wall
340 & 342

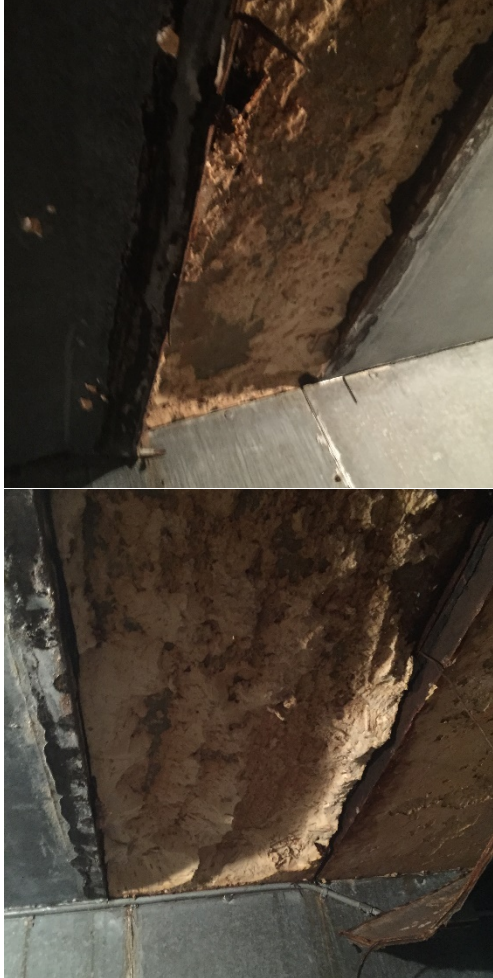
Two photographs showing a ceiling area. The top photograph shows a close-up of a ceiling corner where a metal beam meets a wall. The ceiling material is heavily damaged, with large areas of peeling and crumbling, revealing a brown, moldy interior. The bottom photograph shows a similar view from a different angle, highlighting the extent of the structural damage and mold growth.	Collapsing ceiling at food cooler addition

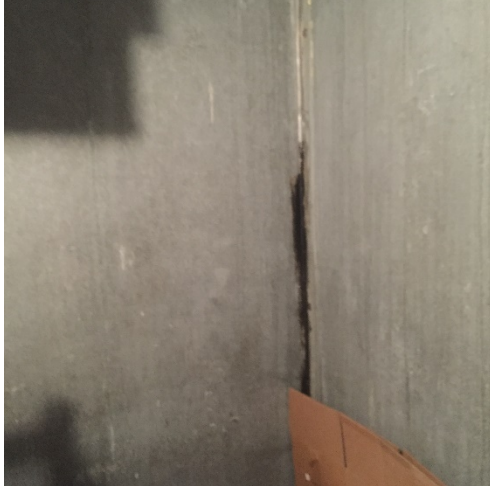
Mold at wall in food cooler
343

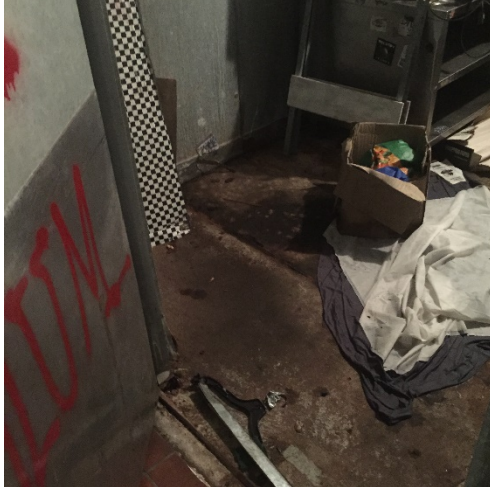
Mold at floor in food cooler
132

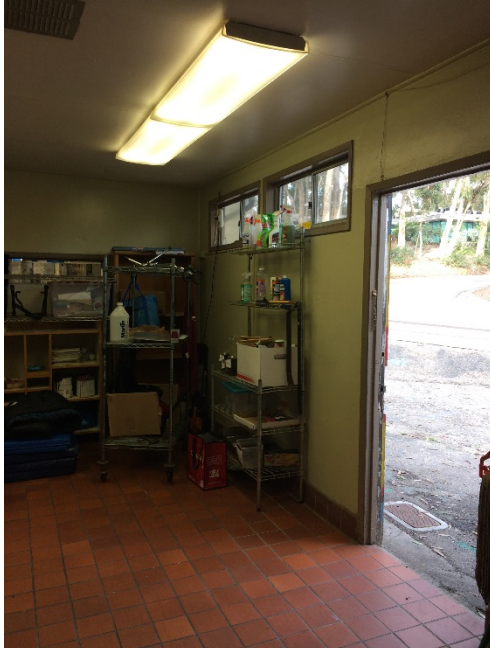
Kitchen addition without foundation

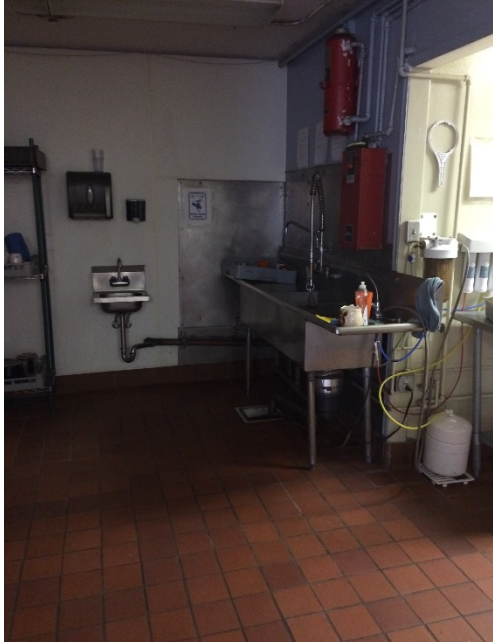
Non-code-compliant electrical
146

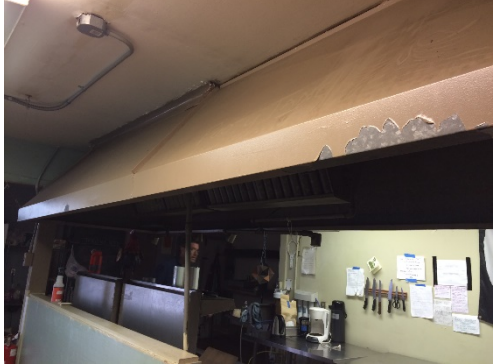
Evidence of roof leak
150

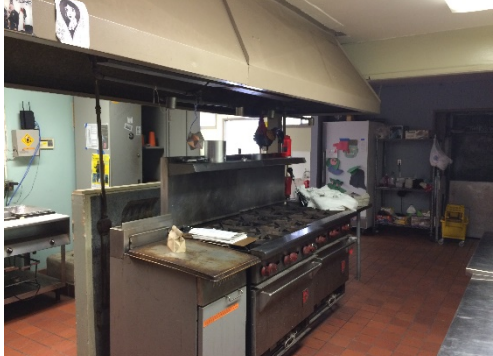
Non-code-compliant roof. No sprinkler. Electrical should not be inside.

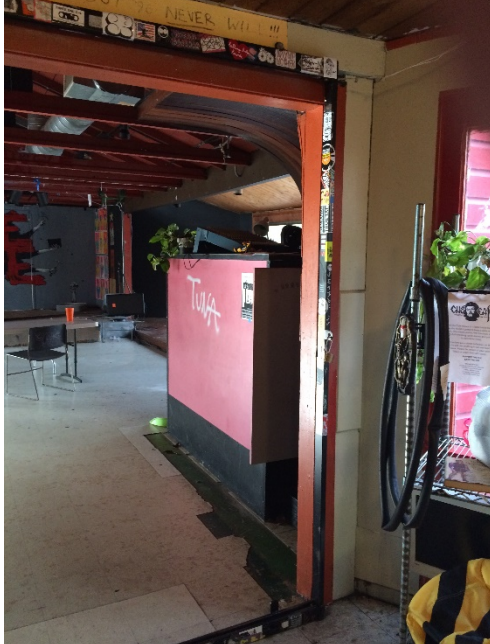
A photograph showing a doorway leading into a room. A metal gate track is visible at the top of the doorway. To the right of the doorway, a pink wall has the word 'TUSA' written on it. A bicycle is leaning against a counter to the right. The room beyond the doorway has a table and chairs.	Gate track impedes ADA accessibility to RRs and café. No ADA access to patio.
160

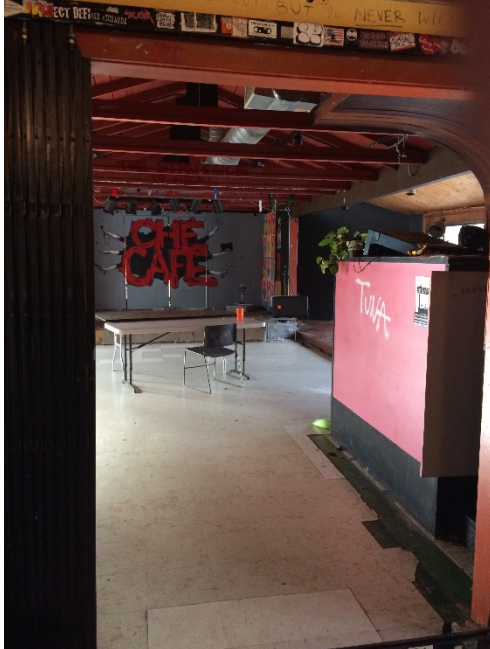
A photograph showing a doorway leading into a room. The structural rafters above the doorway are high and exposed. To the right of the doorway, a pink wall has the word 'TUSA' written on it. The room beyond the doorway has a table and chairs.	Height of structural rafters invite abuse

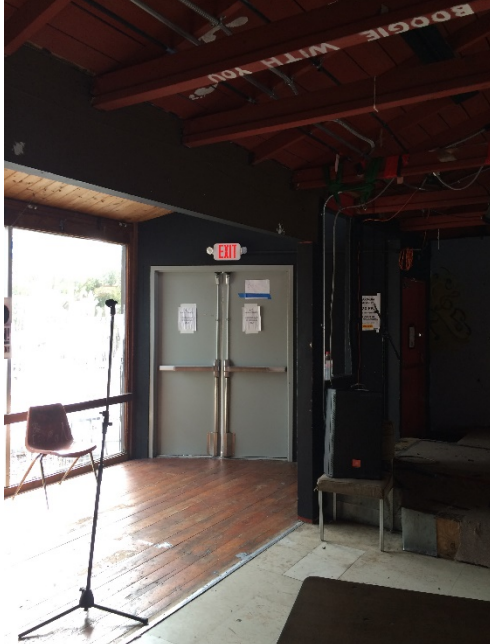
A photograph showing the interior of a room. The floor is made of light-colored wood. In the background, there is a doorway with a red "EXIT" sign above it. The ceiling is dark with exposed wooden beams and various electrical wires and conduits running across it. A black tripod stand is visible in the foreground on the left.	Non-code-compliant electrical
174

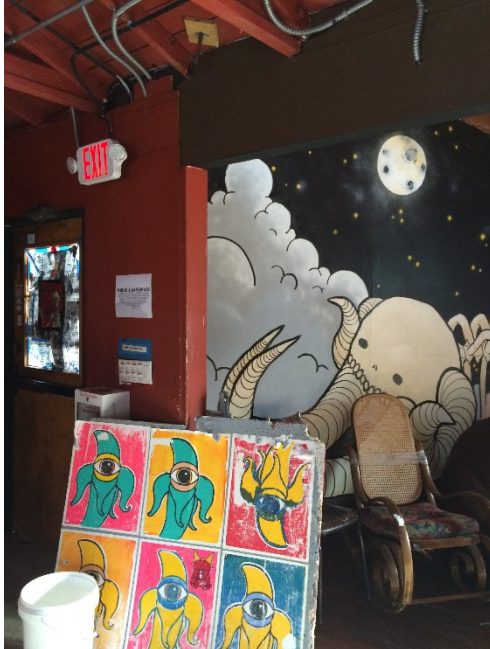
A photograph of a room with a mural on the wall. The mural depicts a large, horned creature (possibly a dragon or a dinosaur) in a dark space with a full moon and stars. In the foreground, there is a table covered with several colorful, hand-drawn cards or posters. A white bucket is on the floor next to the table. An "EXIT" sign is visible on the wall to the left.	Non-code compliant electrical. Poorly supported beam

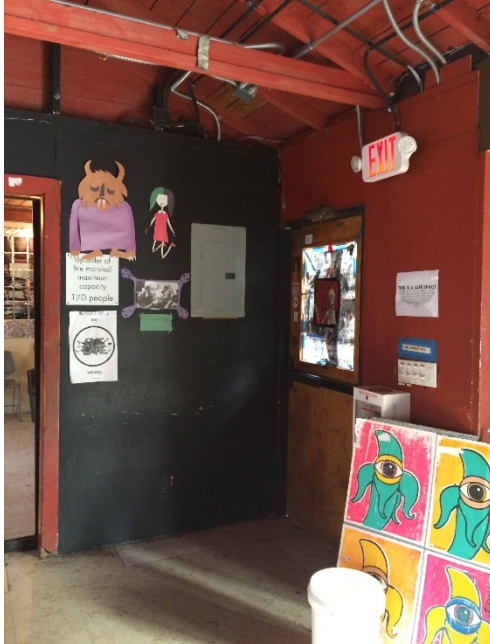
Non-usable exit
179

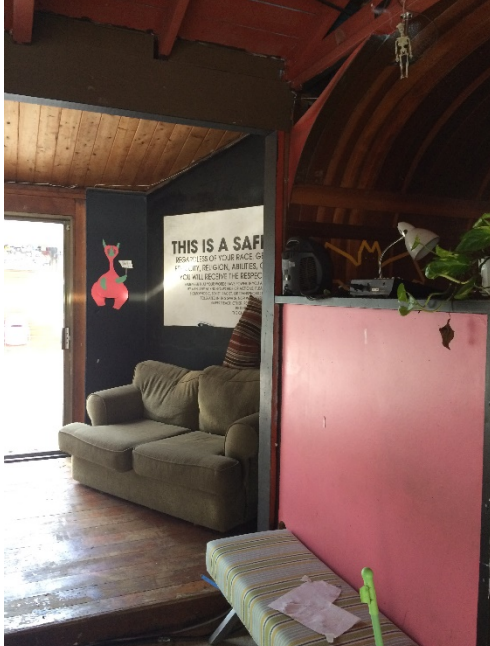
Poorly supported Beam
204 & 182

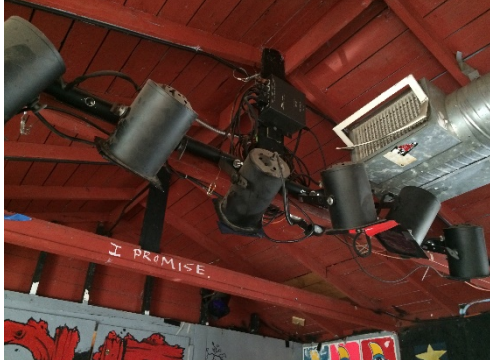
A photograph showing a red-painted ceiling with a complex arrangement of electrical wires, conduits, and components. A metal electrical panel is visible, and the word "PROMISE" is partially visible on a red beam below.	Overloaded Electrical
194

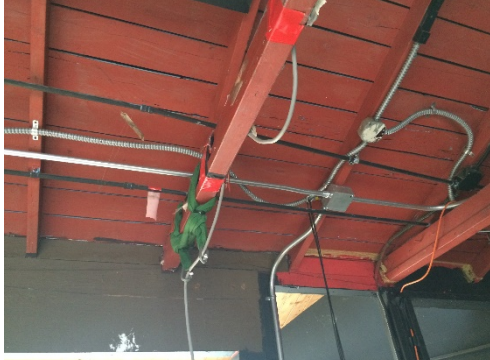
A photograph of a red-painted ceiling showing electrical wiring that is not properly enclosed in conduit or raceway, running haphazardly across the ceiling joists.	Non-code-compliant electrical
201

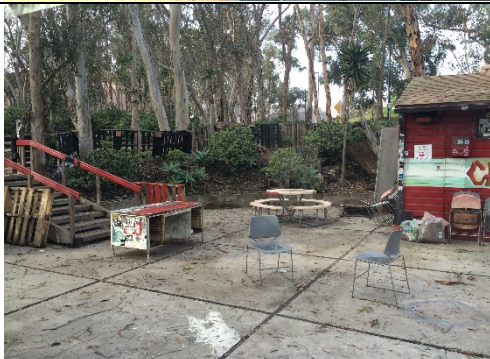
A photograph of an outdoor patio area with a concrete floor. There are several blue chairs and a small table. A red ramp or staircase is visible in the background, leading to a higher level. The area appears to be difficult to access.	Inaccessible patio
203

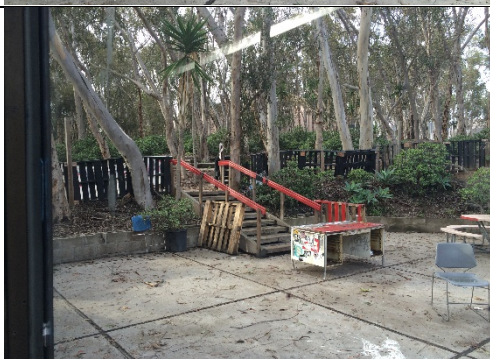
A photograph showing a red-painted exit stair leading up to a higher level. The stairs appear to be made of wood and are not properly enclosed or protected, which is non-compliant with building codes.	Non-code compliant exit stair

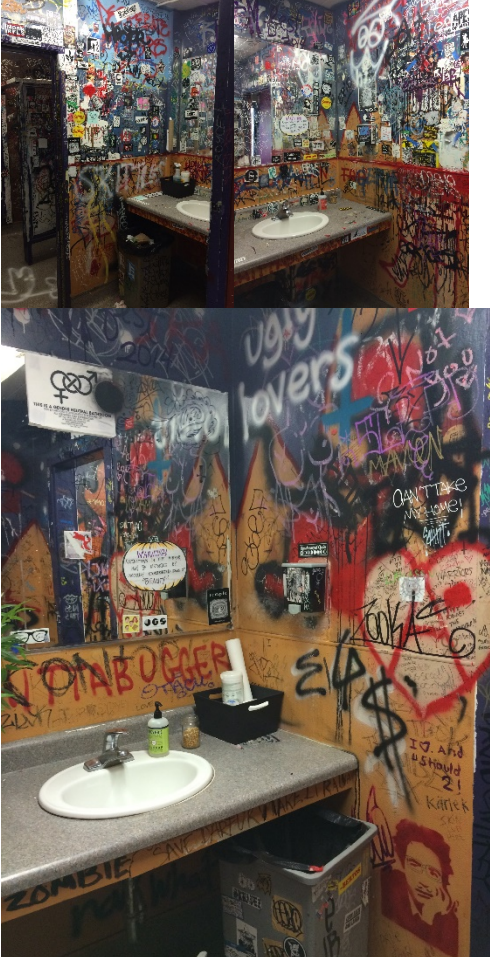
Non-code compliant RRs
230

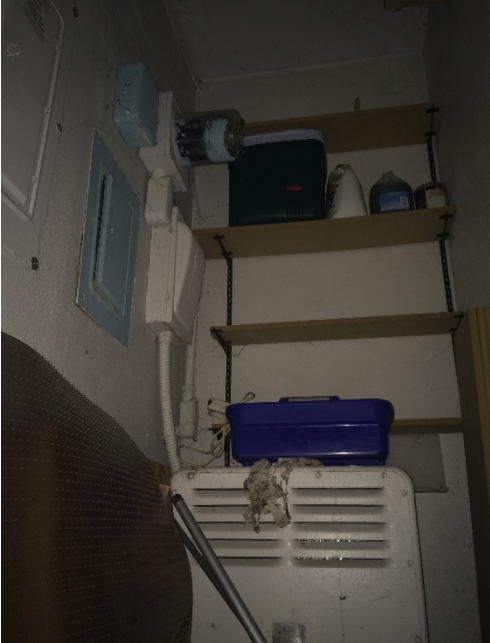
The electrical infrastructure of the whole complex is outdated. The installation of the main electrical panel does not meet code and there is no adequate ventilation. Multiple deficiencies in the electrical distribution were noted. Only the Assembly Area appeared to have adequate HVAC service, but the equipment mounted on the roof does not meet code.

Inadequate Ventilation. Non-code-compliant electrical closet.

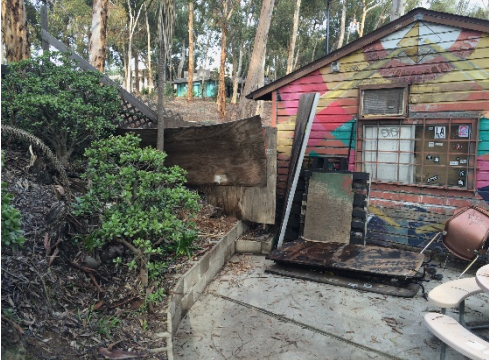
A photograph showing the exterior of a building with colorful, multi-colored siding. A concrete pad is in the foreground, and there is a drainage issue where water is pooling or running off the pad. The building has a window with a sign that says "35".	Poor Sight Drainage
245

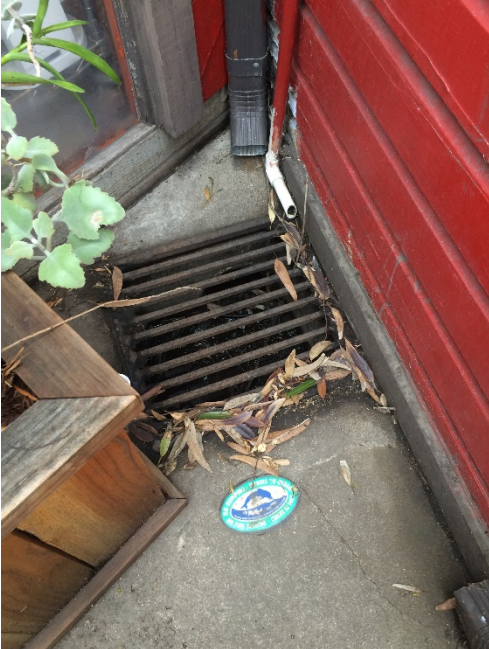
A close-up photograph of a storm drain. The drain is covered with a metal grate and is surrounded by a concrete pad. There is a significant amount of debris, including leaves and twigs, piled up around the drain. A blue circular object is visible on the concrete pad in the foreground.	Non-Compliant Storm System
249

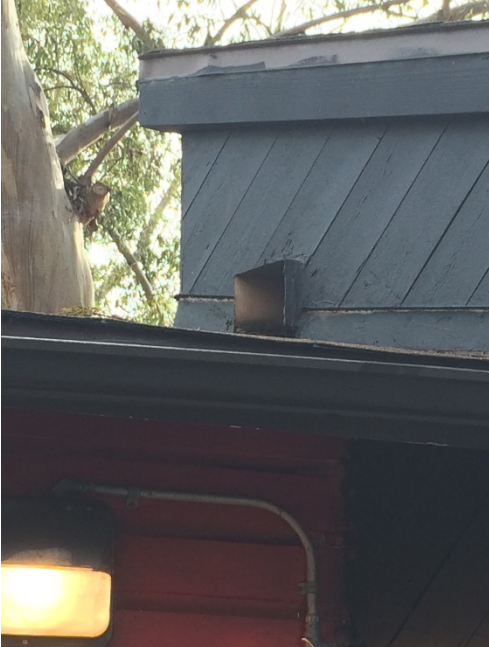
A close-up photograph of the exterior siding of a building. The siding is dark grey or black and shows signs of rot and decay. A small, dark, rectangular object is visible on the siding, possibly a vent or a piece of debris. The background shows trees and a bright sky.	Evidence of Exterior Rot

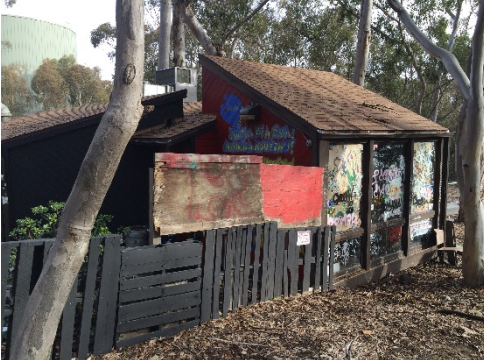
Poor Site Conditions
257

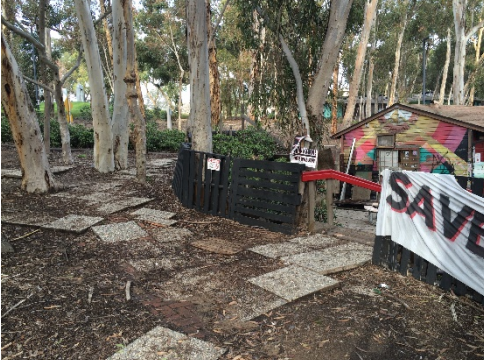
Inaccessible Site Access
258

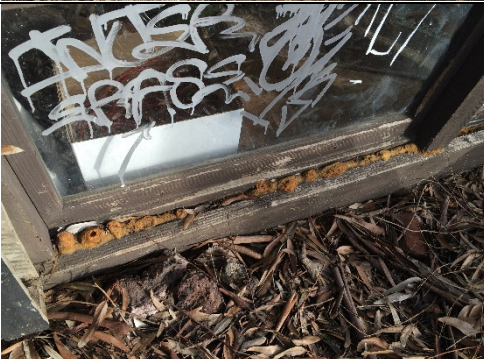
Mold In Wall
259

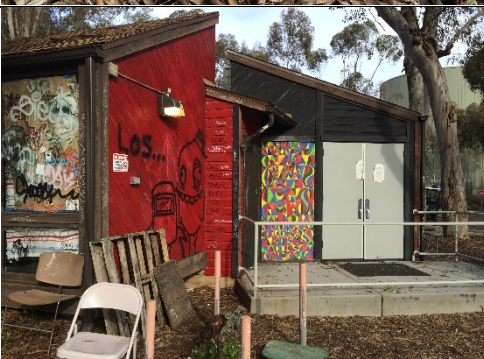
Roofing in Poor Condition

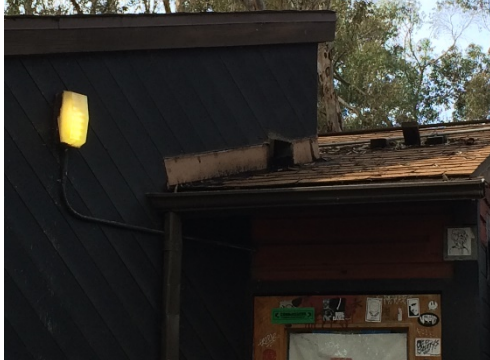
Leaks at Flashing
270

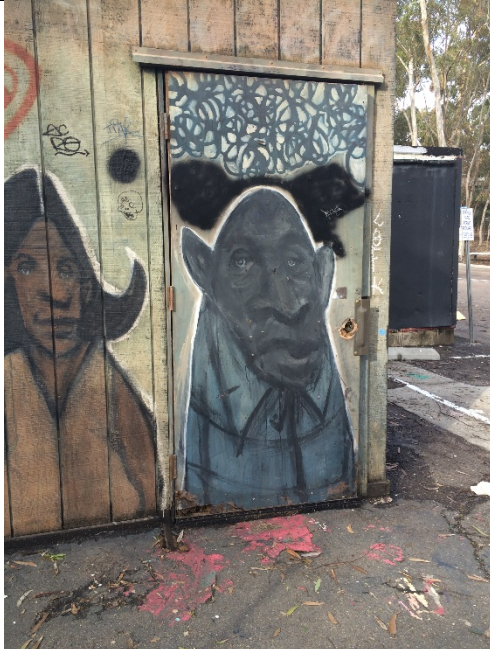
Room addition on Asphalt. No Footings.
271

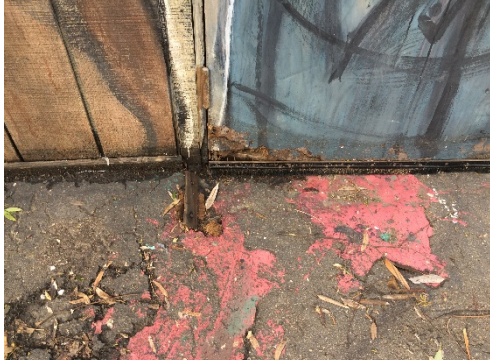
No Foundation. Evidence of Rot in Walls.

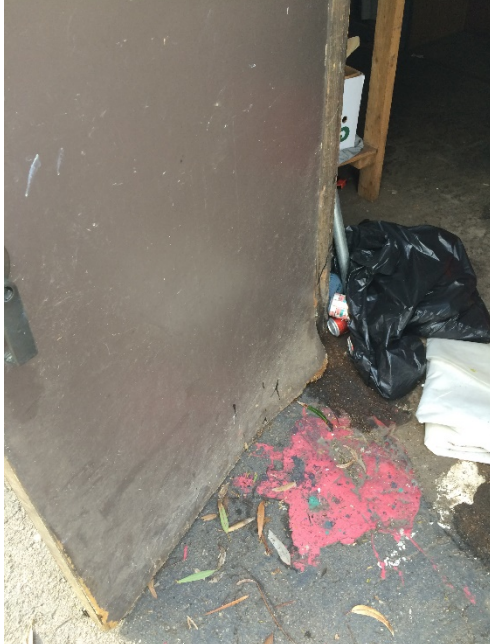
Door Decay
278

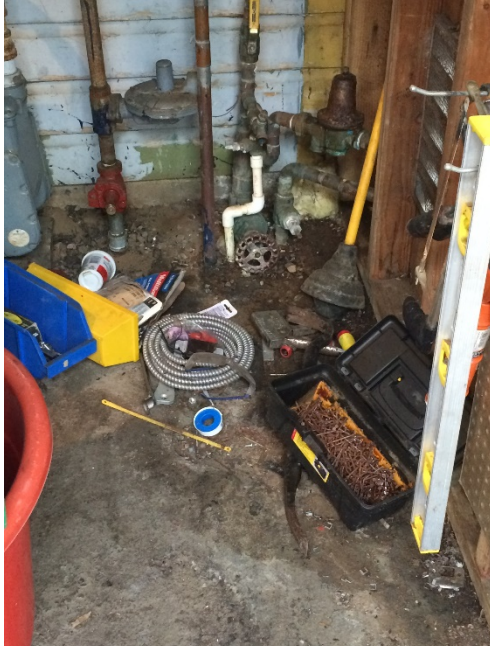
Non-Compliant utility service in enclosed space
282

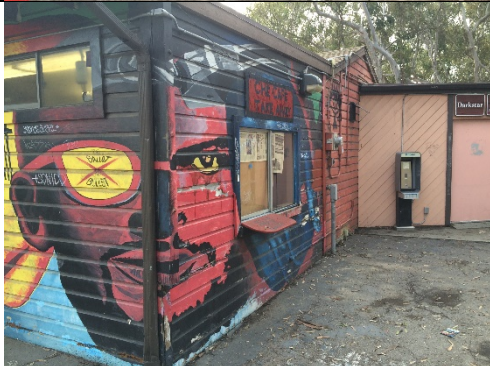
Evidence of rotting plates at Exterior Walls

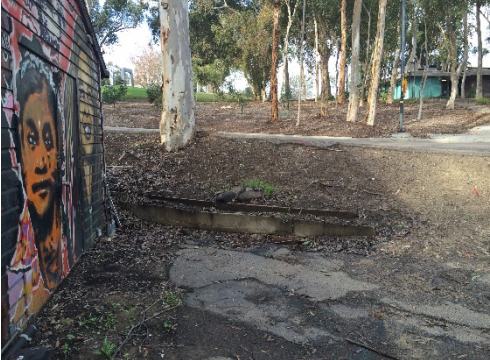
A photograph showing the exterior of a building with a colorful mural on its wall. In the foreground, there is a concrete drainage ditch that appears to be partially blocked or overflowing, with water visible. The ground around the ditch is dirt and some sparse vegetation.	Site Drainage into Building
297

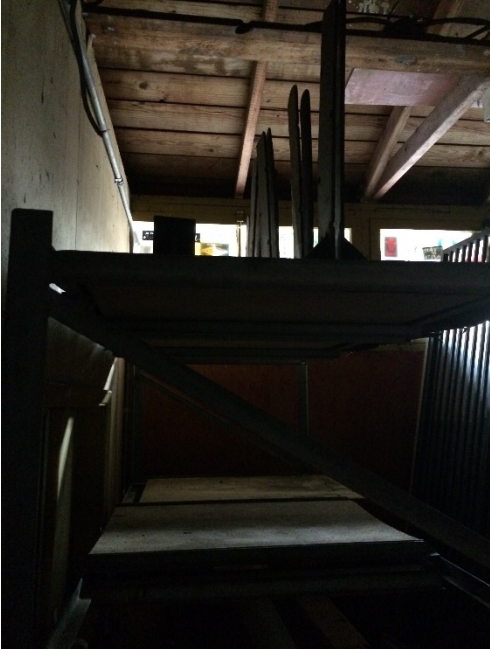
A photograph taken from the interior of a building, looking upwards. It shows a complex network of wooden beams and structural supports. The lighting is somewhat dim, highlighting the textures of the wood.	Roof Leaks
301

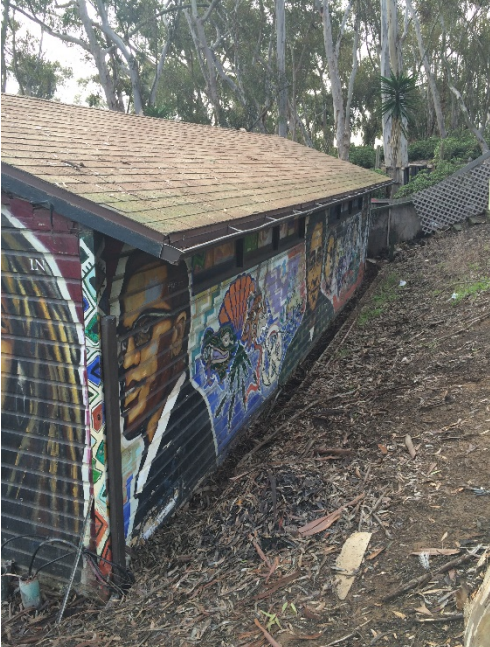
A photograph showing the exterior of a building with a large, colorful mural on its side. The building has a gabled roof with shingles. In the foreground, there is a drainage ditch filled with debris and some water. The ground is covered with dry leaves and twigs.	Site Drainage into Building

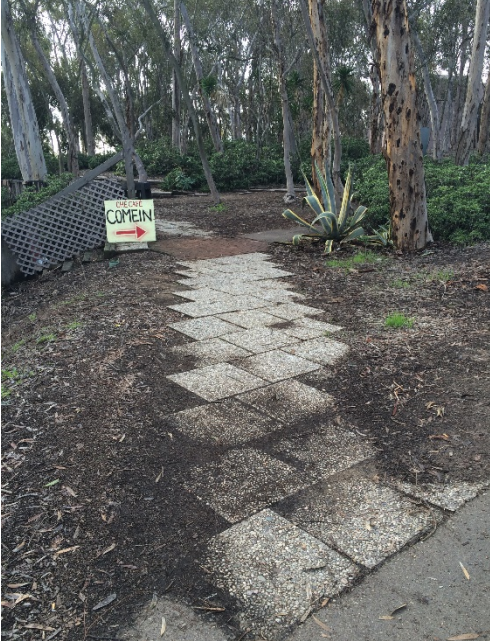
Inaccessible Entrance
