UNIVERSITY OF CALIFORNIA, SAN DIEGO

PRICE CENTER-EAST

FACILITY CONDITION ANALYSIS

SEPTEMBER 15, 2010

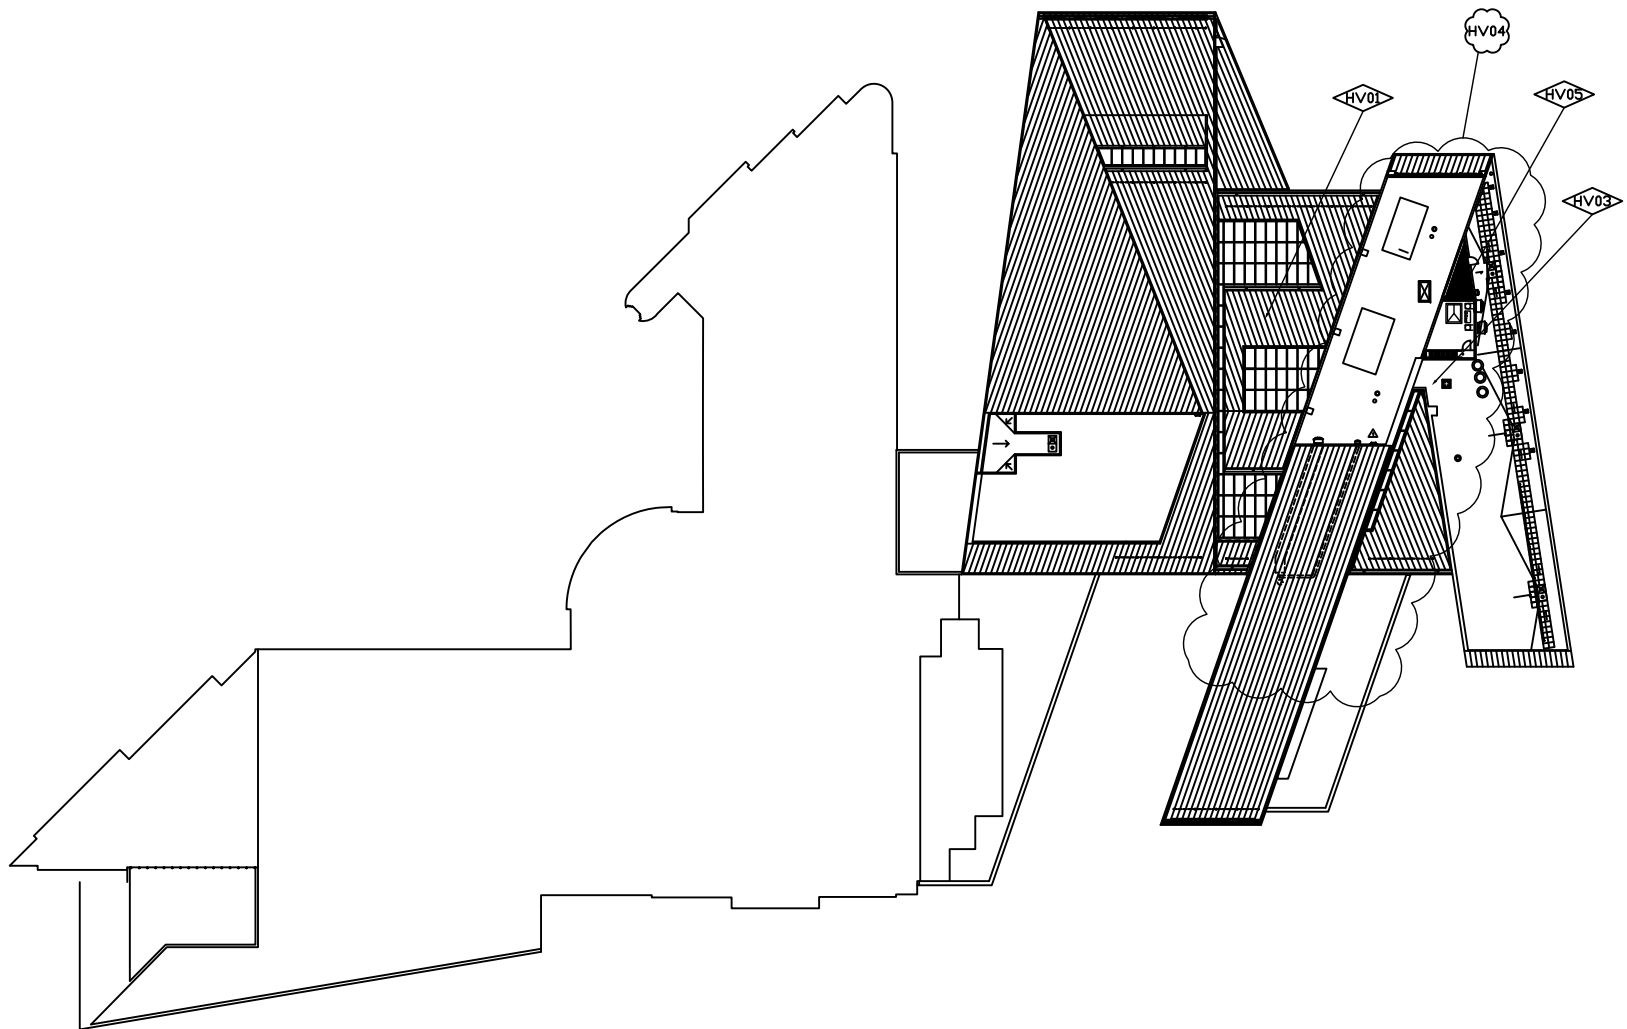
FS01

This building lacks a vertical roof access ladder. The installation of such a ladder, with an OSHA compliant safety cage and platform, is recommended to help limit University liability.
