UNIVERSITY OF CALIFORNIA, SAN DIEGO

CRAFTS CENTER / GROVE GALLERY

FACILITY CONDITION ASSESSMENT

INSPECTION DATE: APRIL 25, 2012

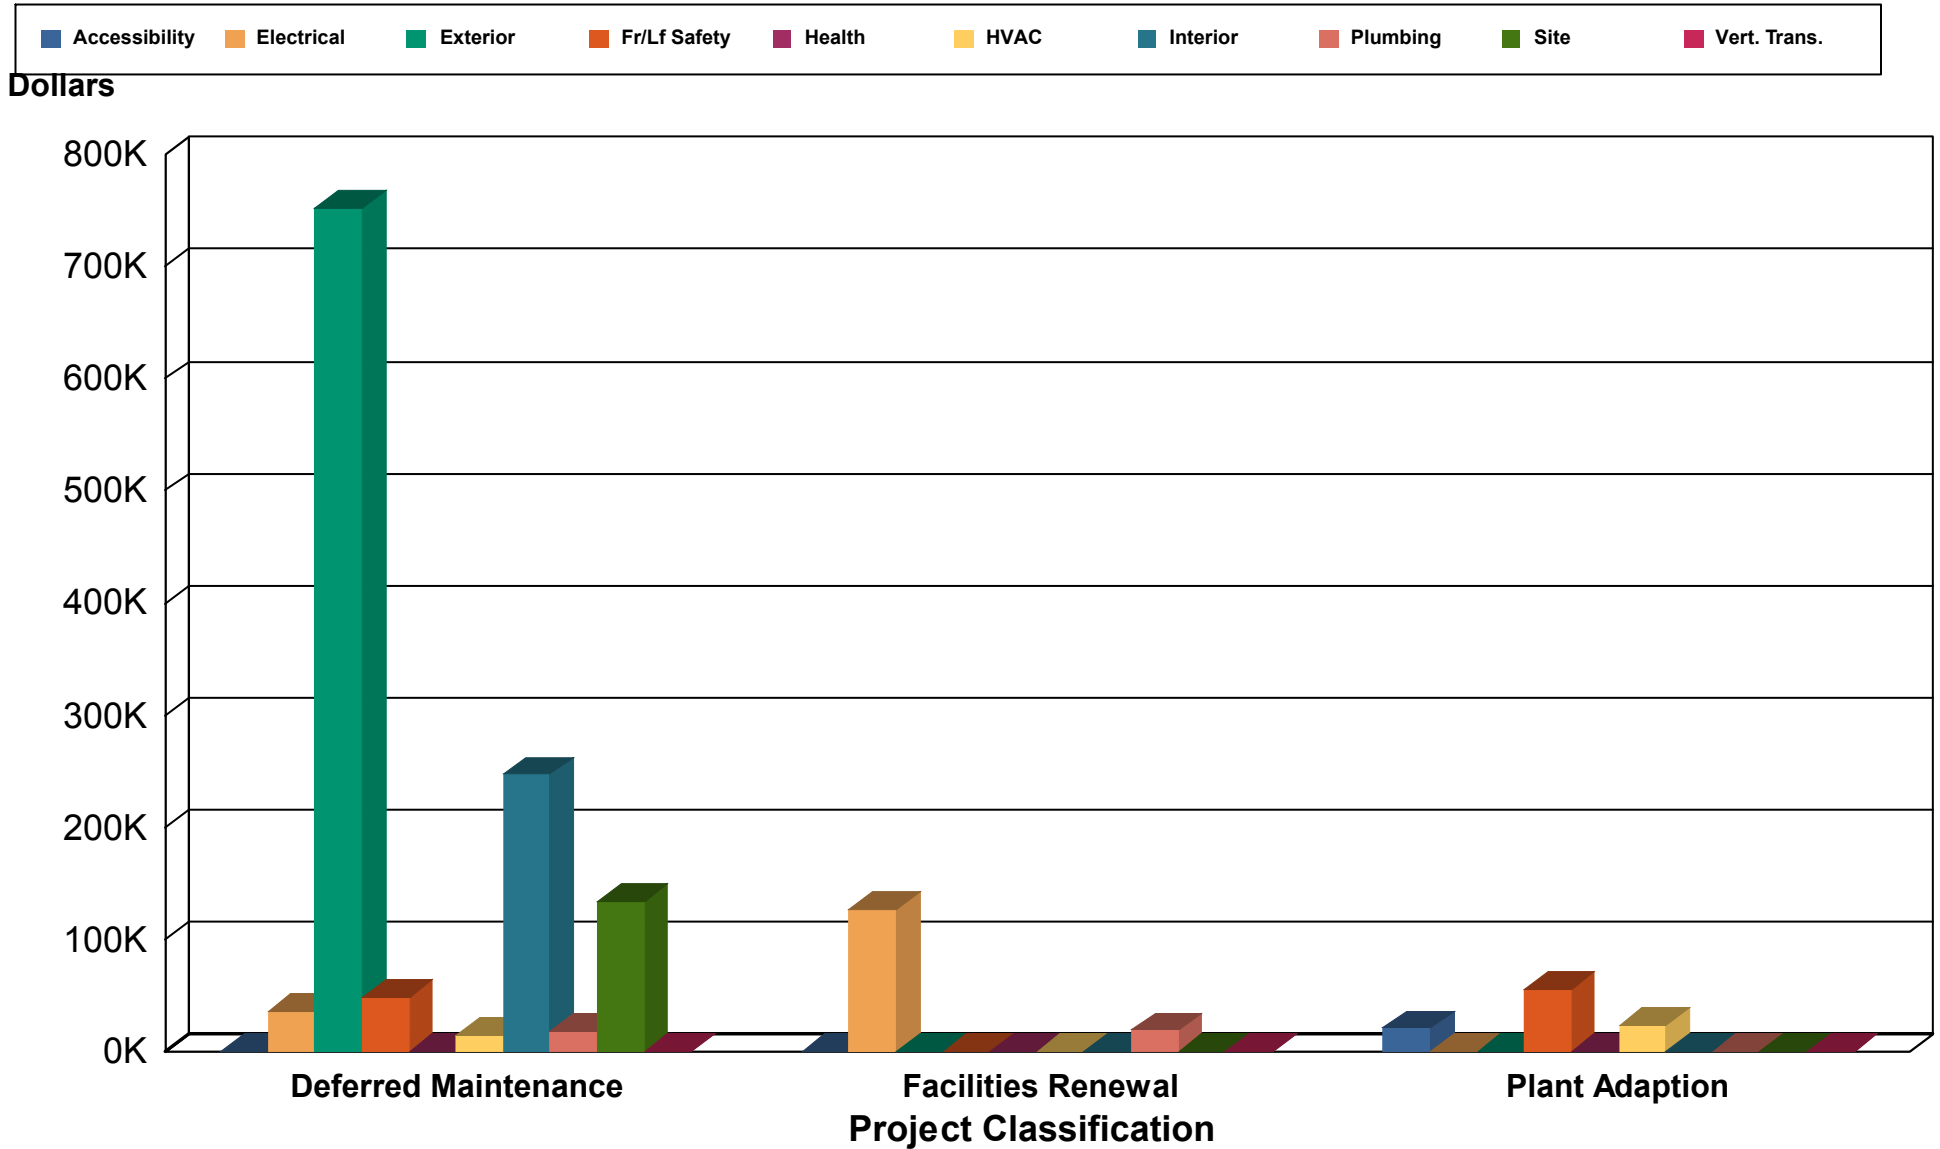
System Code by Project Class

Plant Adaption: Projects to bring building to current standard.

Deferred Maintenance: Remedies for current deficiencies.

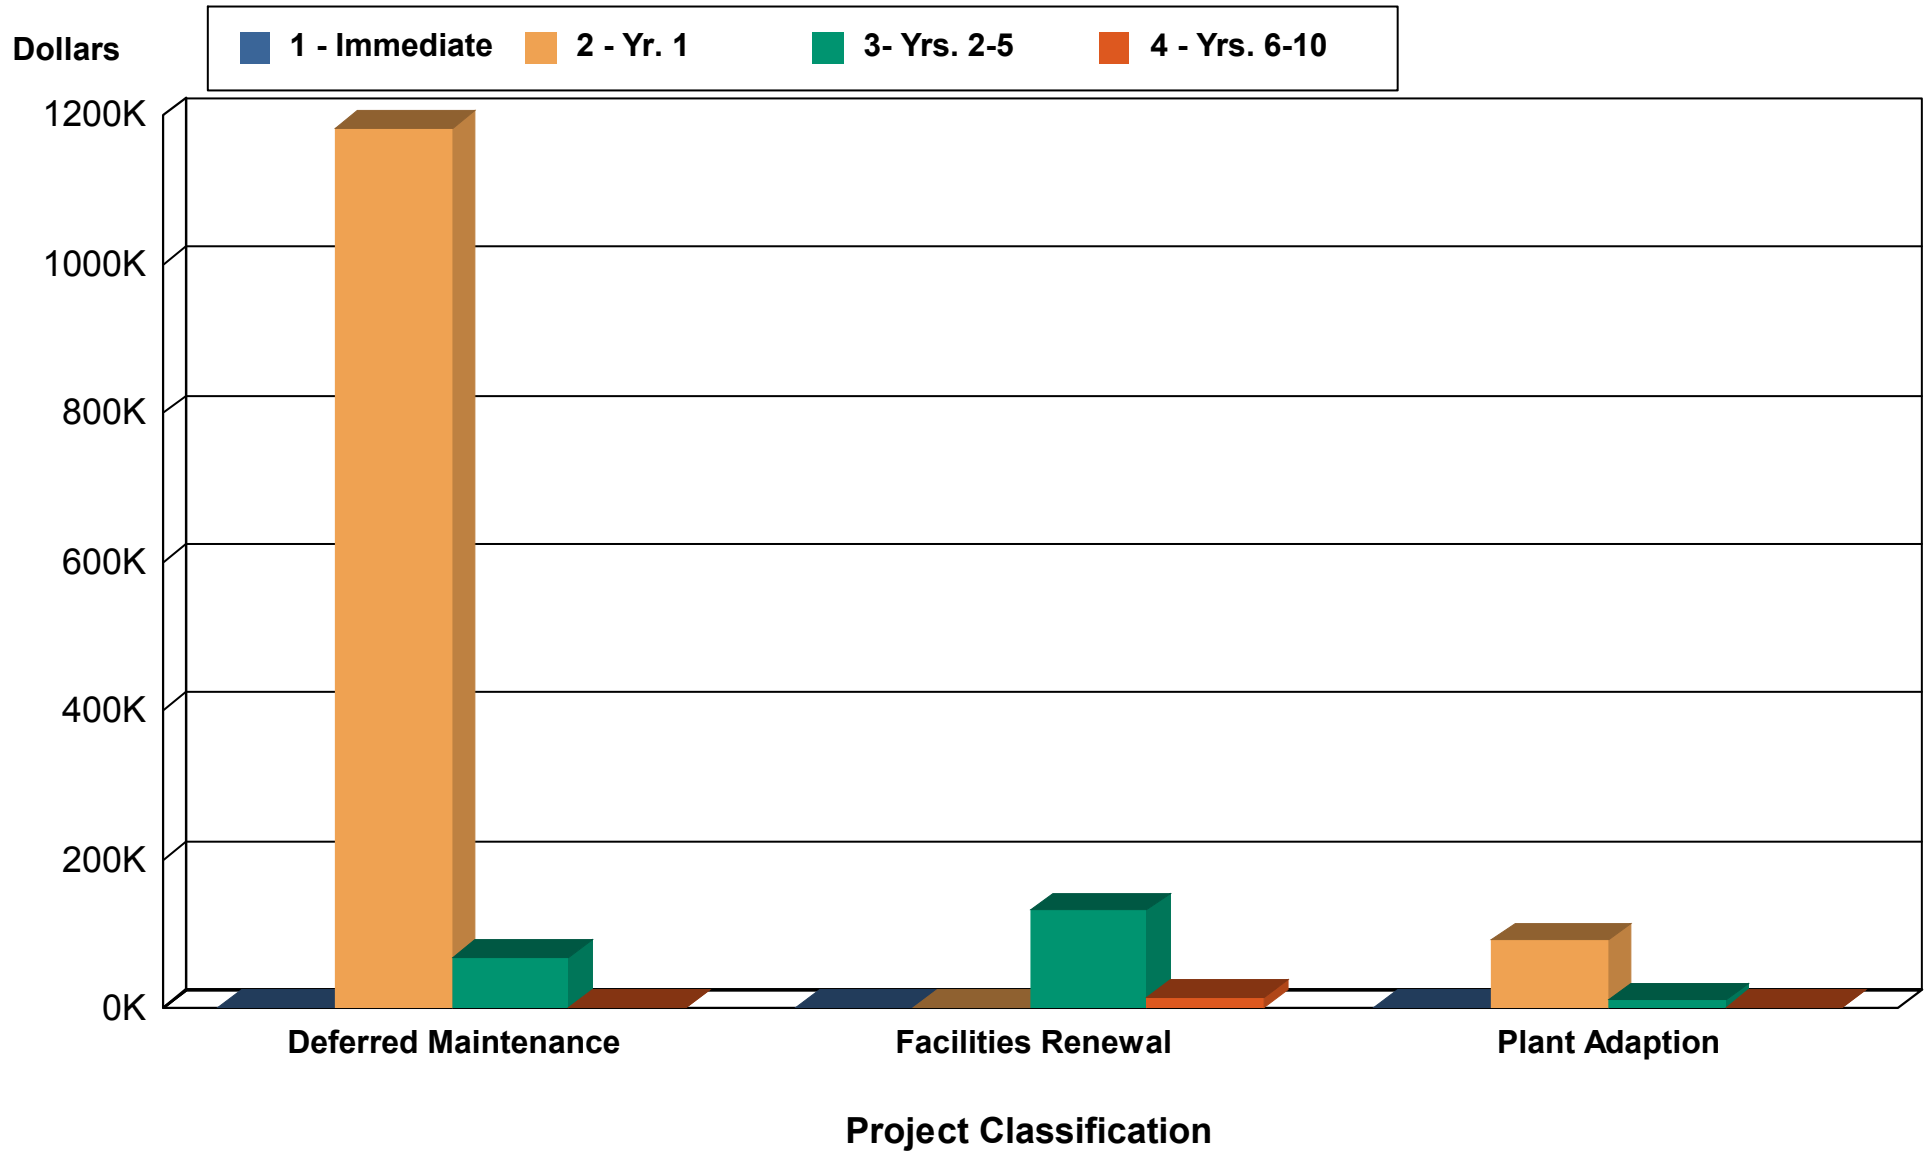
Project Class by Priority Class

Plant Adaption: Projects to bring building to current standard.

Deferred Maintenance: Remedies for current deficiencies.

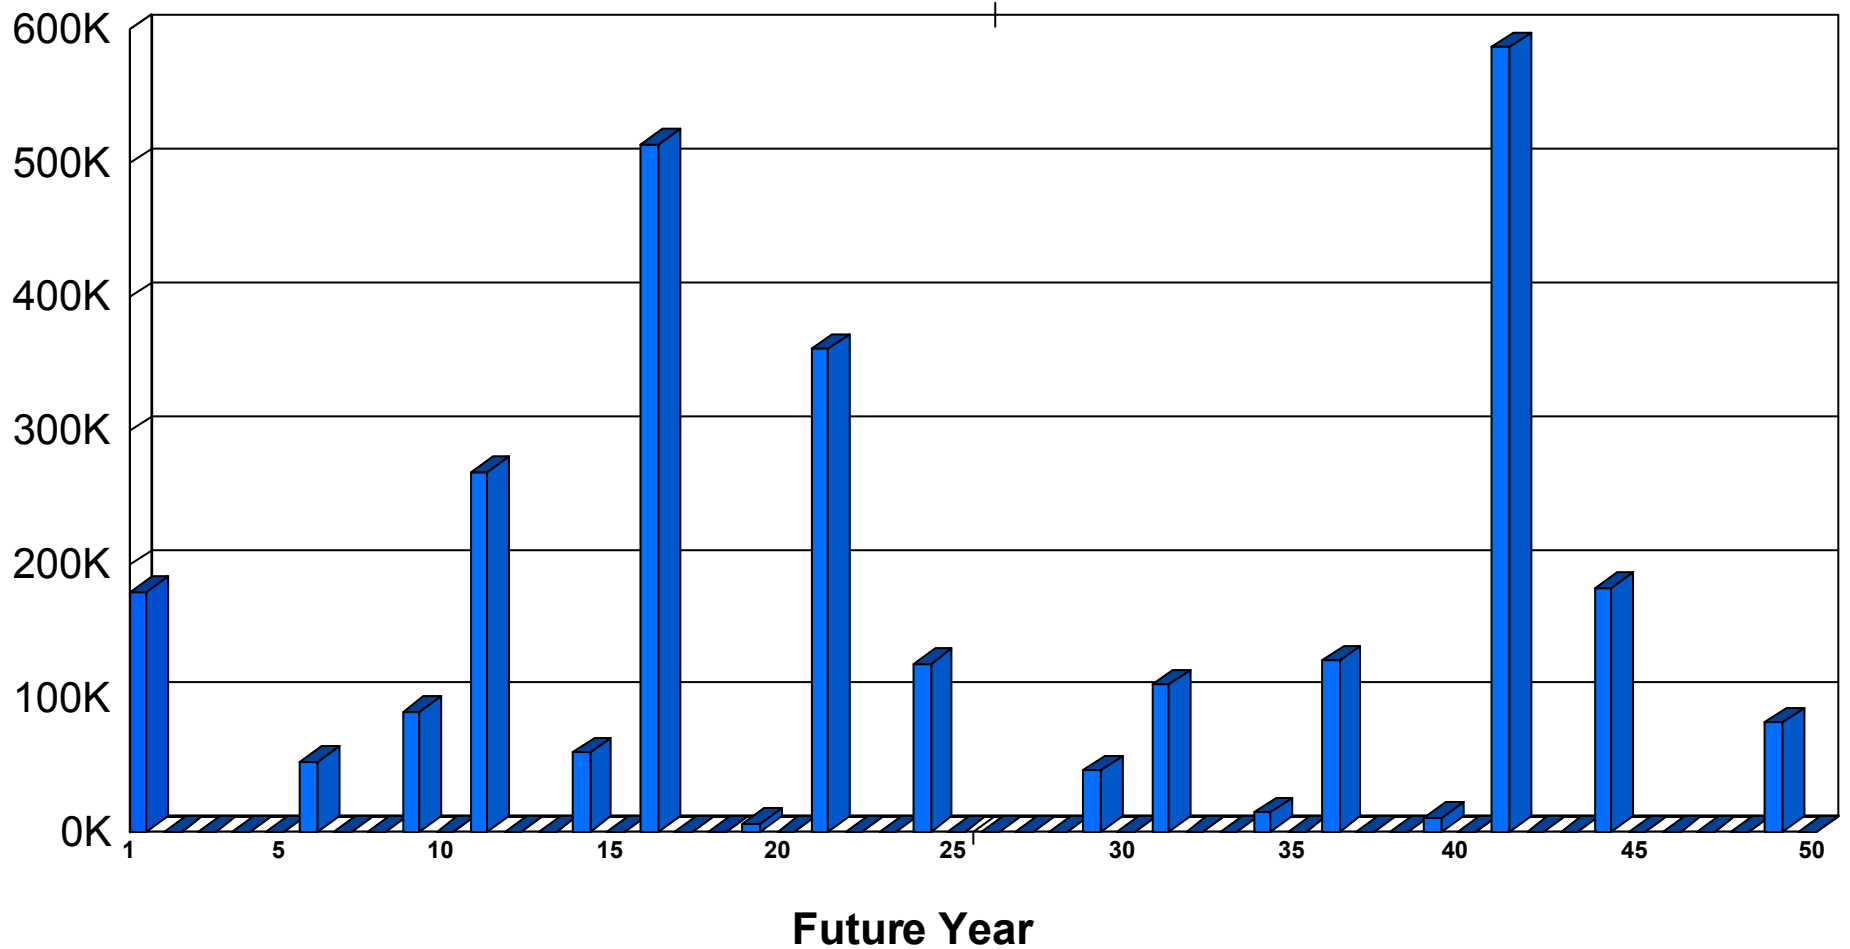
Life Cycle Model Expenditure Projections (Escalated)

Average Annual Renewal Cost per SqFt \$3.32 (Curr. Yr. \$)

The Life Cycle Model displays the maximum reinvestment schedule. This model is an ideal and does not provide for deferred maintenance.
